# Deterioration Types of Stones Used in Suleymaniye Mosque (Istanbul, Turkey)

**Candan Alptekin Bilen [1], Sinem Erisis [1], Selman Er [1], Murat Yılmaz [1], Serkan Angı [2], Atiye Tugrul [1]**

[1] Istanbul University, Department of Geological Engineering, İstanbul-Turkey
[2] Istanbul Technical University, Department of Geological Engineering, İstanbul-Turkey

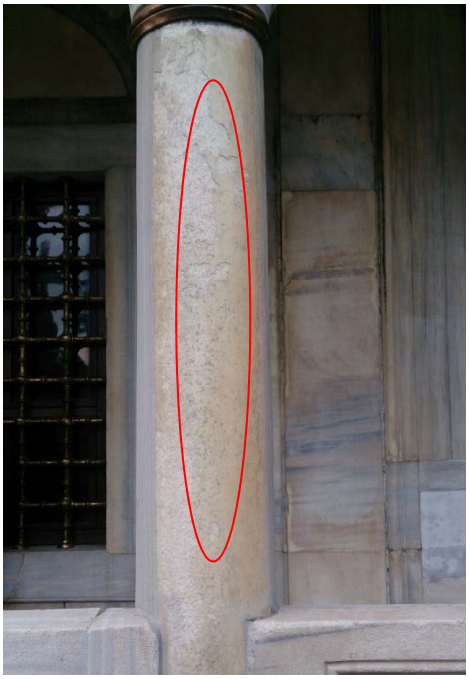
Peeling of stone caused by an inherent defect in the surface of the masonary and columns or the result of weathering [2]. This type of deterioration was occured depend on atmospheric effects in Marmara Marble column (Figure 3).

**Figure 3.** The view of peeling on the surface of Marmara Marble

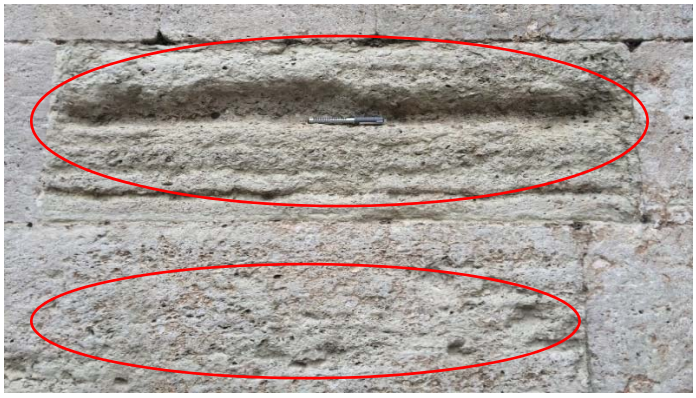
Karst developed on the base of a chalk column particularly exposed to water. The chemical processes of deterioration the role of water is very important because of the phenomena of dissolution, hydrolysis and hydration. The other effect of water is moving from inside the core of the wall outward via the stones instead of through the joints. This situation has led to accelerated deterioration of the building stones. The carbonic acid that causes these features is formed as rain passes through the atmosphere picking up carbon dioxide ($CO_2$), which dissolves in the water. Once the rain reaches the ground, it may pass through soil that can provide much more $CO_2$ to form a weak carbonic acid solution, which dissolves calcium carbonate [4]. Bakırkoy limestone with plenty of fossil shelled, fractured and dissolution of voids cause to karst formation by accelerating the movement of the water. Especially this deterioration type was observed on wall (Figure 6).

**Figure 6.** The view of karst in Kufeki Stone
